Three-dimensional laser scanning test in aircraft surfaces

Luis MIRANDA and Daniel PAEZ, Universidad de los Andes (Colombia)

SUMMARY

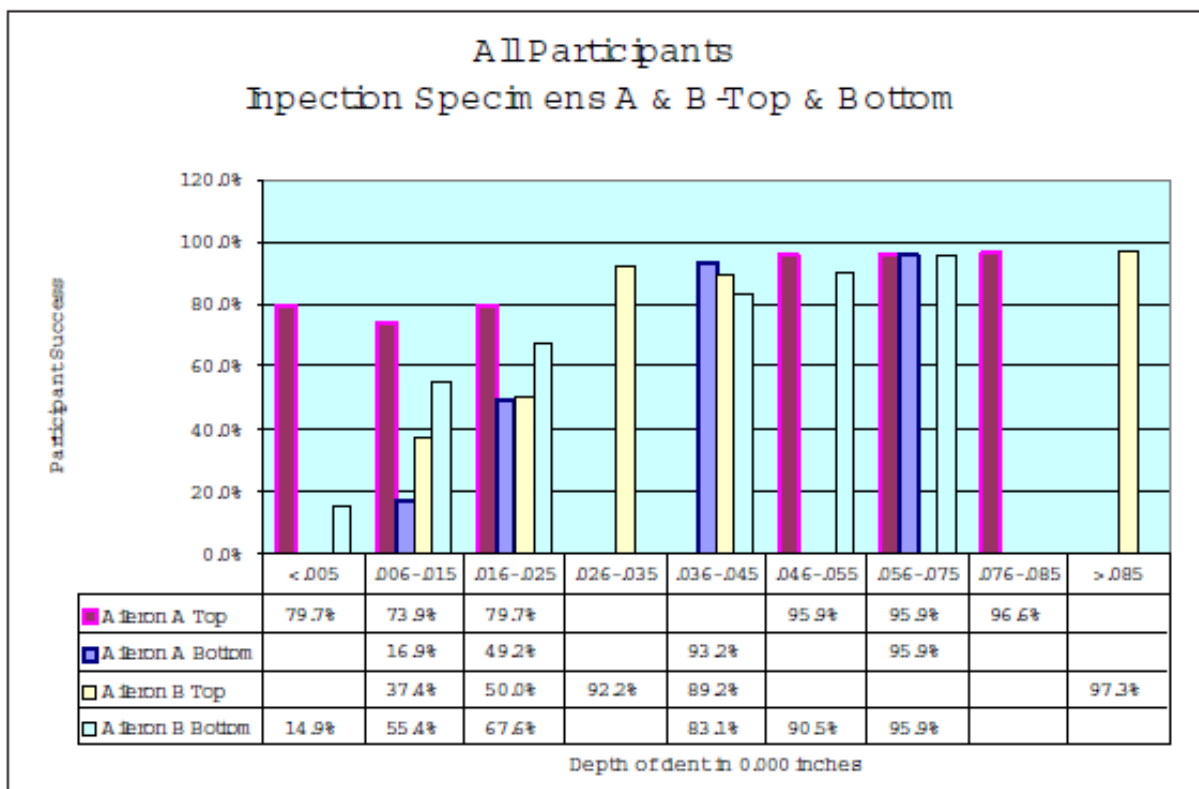
FIGURE 1. SUMMARY GRAPH, PARTICIPANTS-INSPECTION SPECIMENS A&B (ERCHART, OSTROM, & WILHELMSEN, 2004)

Figure 1 shows that there is no clear differentiation in the attention to details between men or women. It also shows that dents greater than 0.06 inches are identifiable in more than 80% of cases. It is, therefore, questionable that current visual inspections are sufficient as there are a 20% of dents that are not identified, compromising flight safety (Erchart, Ostrom, & Wilhelmsen, 2004).

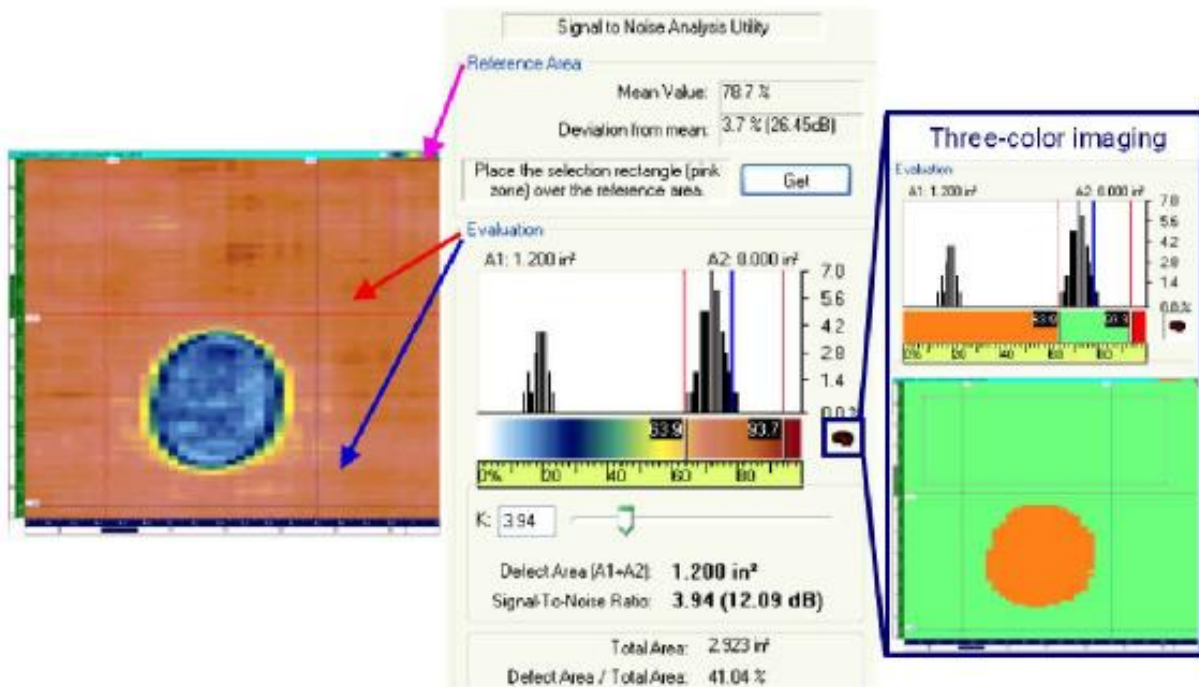
FIGURE 2. REPRESENTATIVE RESULTS ON AN AMPLITUDE C-SCAN (LEFT), C-SCAN CONVERTED INTO THREE COLORS FOR ASSISTED DEFECT VIEWING (RIGHT) (HABERMEHL, LAMARRE, & ROACH, 2009)

With this, technique data interpretation is easier compared to amplitude or time-of-flight (TOF) because a color-coded map of large areas is provided by the C-scans, where echo amplitudes are recorded in relation to probe position and represent the main defect viewing. To detect all defects from areas the previously mentioned scans require an appropriate gate. However, in some cases it can be used the amplitude base method, that doesn't requires an appropriate gate by a direct delamination detection or monitoring the backwall drop. Regardless of the good results of the methods mentioned before, there are some limitations with the mid-range (Habermehl, Lamarre, & Roach, 2009).

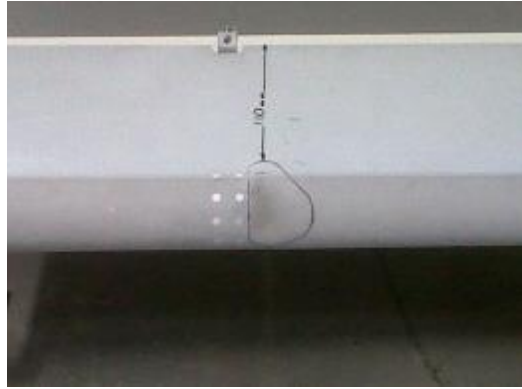
FIGURE 4. DENT ON A320 LEADING EDGE

The case of study was divided in three parts. The first part is a laboratory situation where the engineers need to measure a previous identified dent on an A320 leading edge shown in Figure 4.

For the first part of the case of study, the measures were taken at 1, 2, 4 and 8 meters from the object of interest and with two different angles. We called these two measurements of the leading edge “tilt1” and “tilt2” in the results section. Every single measure took around 2.5 minutes.

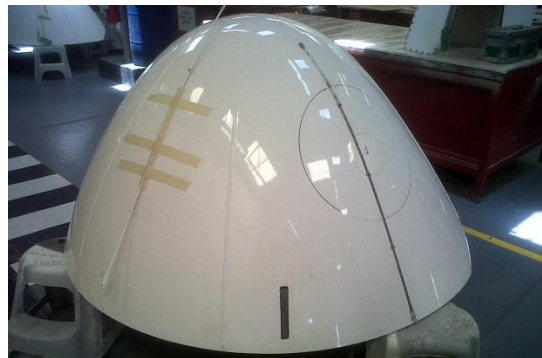
FIGURE 5. A320 NOSE RADOME

The second part is a laboratory situation where the engineers need to identify a scratch on an A320 quartz fiber nose radome, shown in Figure 5.

For the second part two measures were taken, at 4 and 8 meters. Every single measure took 4.5 minutes.

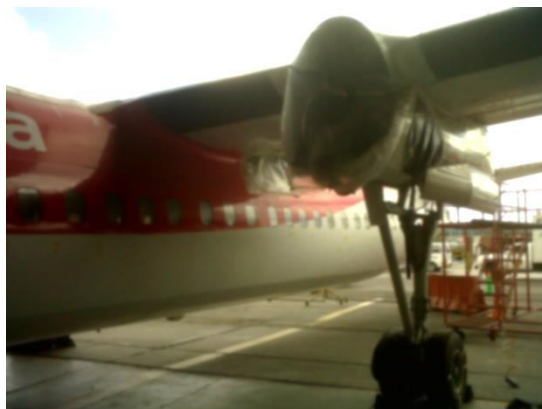
FIGURE 6. AIRCRAFT WING TO BE TESTED

The third part is a simulated practical situation where the engineers need to determine if there are potentially harmful dents on an aircraft wing. The inspected aircraft wing is shown in Figure 6.

Finally, for the third part, two measures were taken at a distance of 4 and 8 meters and every single measure took 10 minutes.

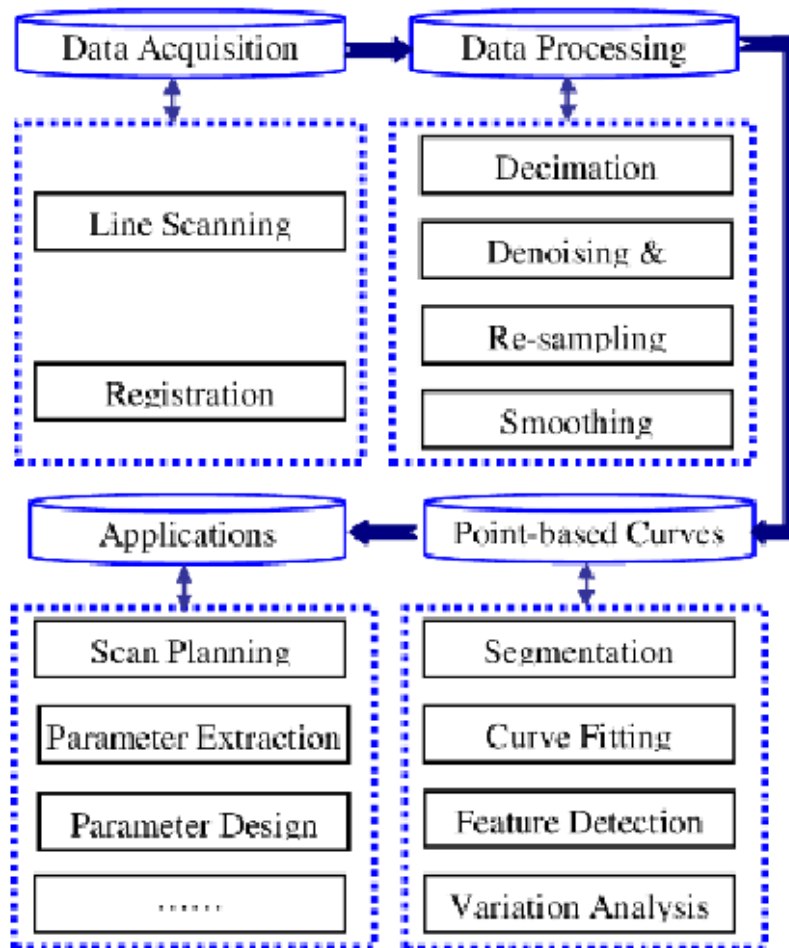
FIGURE 7. DATA PIPELINE AND PROCESSING FRAMEWORK (CHEN, DU, JIA, & SONG, 2010)

The processing of the data is divided into the development of two types of different techniques and methodologies. The first area is identification techniques and the second one is mensuration techniques. Figure 7 shows the processing framework used to create the identification and mensuration techniques.

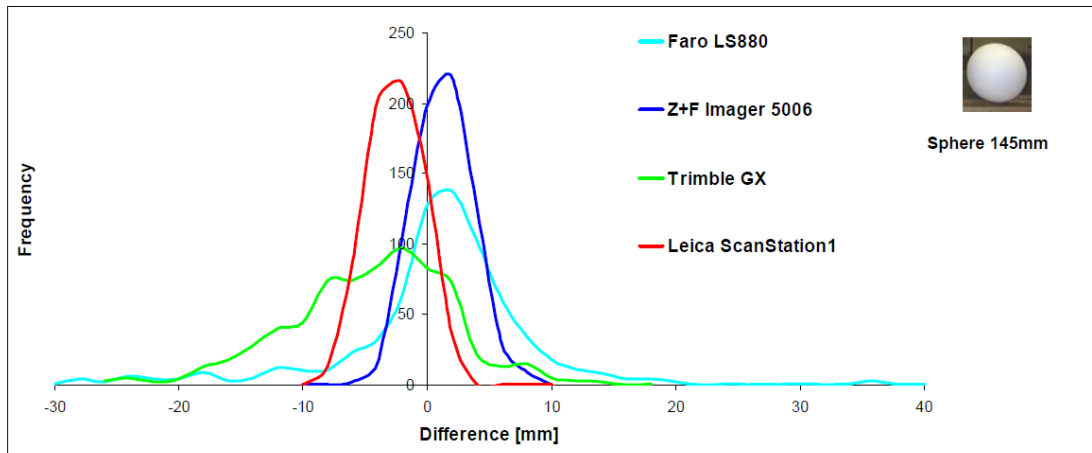
FIGURE 12. DISTRIBUTION OF DIFFERENCES BETWEEN SCANNED DISTANCES AND REFERENCE DISTANCES FOR FOUR TESTED TERRESTRIAL LASER SCANNER (KERSTEN, MECHELKE, LINDSTAEDT, & STERNBERG, 2009)

Figure 12 shows us that the maximum difference between a scanned distance and a reference distance is between 1 and 5 mm.
